Effects of bank vegetation in waterways with special reference to bank erosion, shear strength, root density and channel hydraulics

**Effects of Bank Vegetation in Waterways with Special
Reference to Bank Erosion, Shear Strength, Root Density and
Channel Hydraulics**

**A thesis submitted to the Open University
for the Degree of Doctor of Philosophy
Biology Department
September 1992**

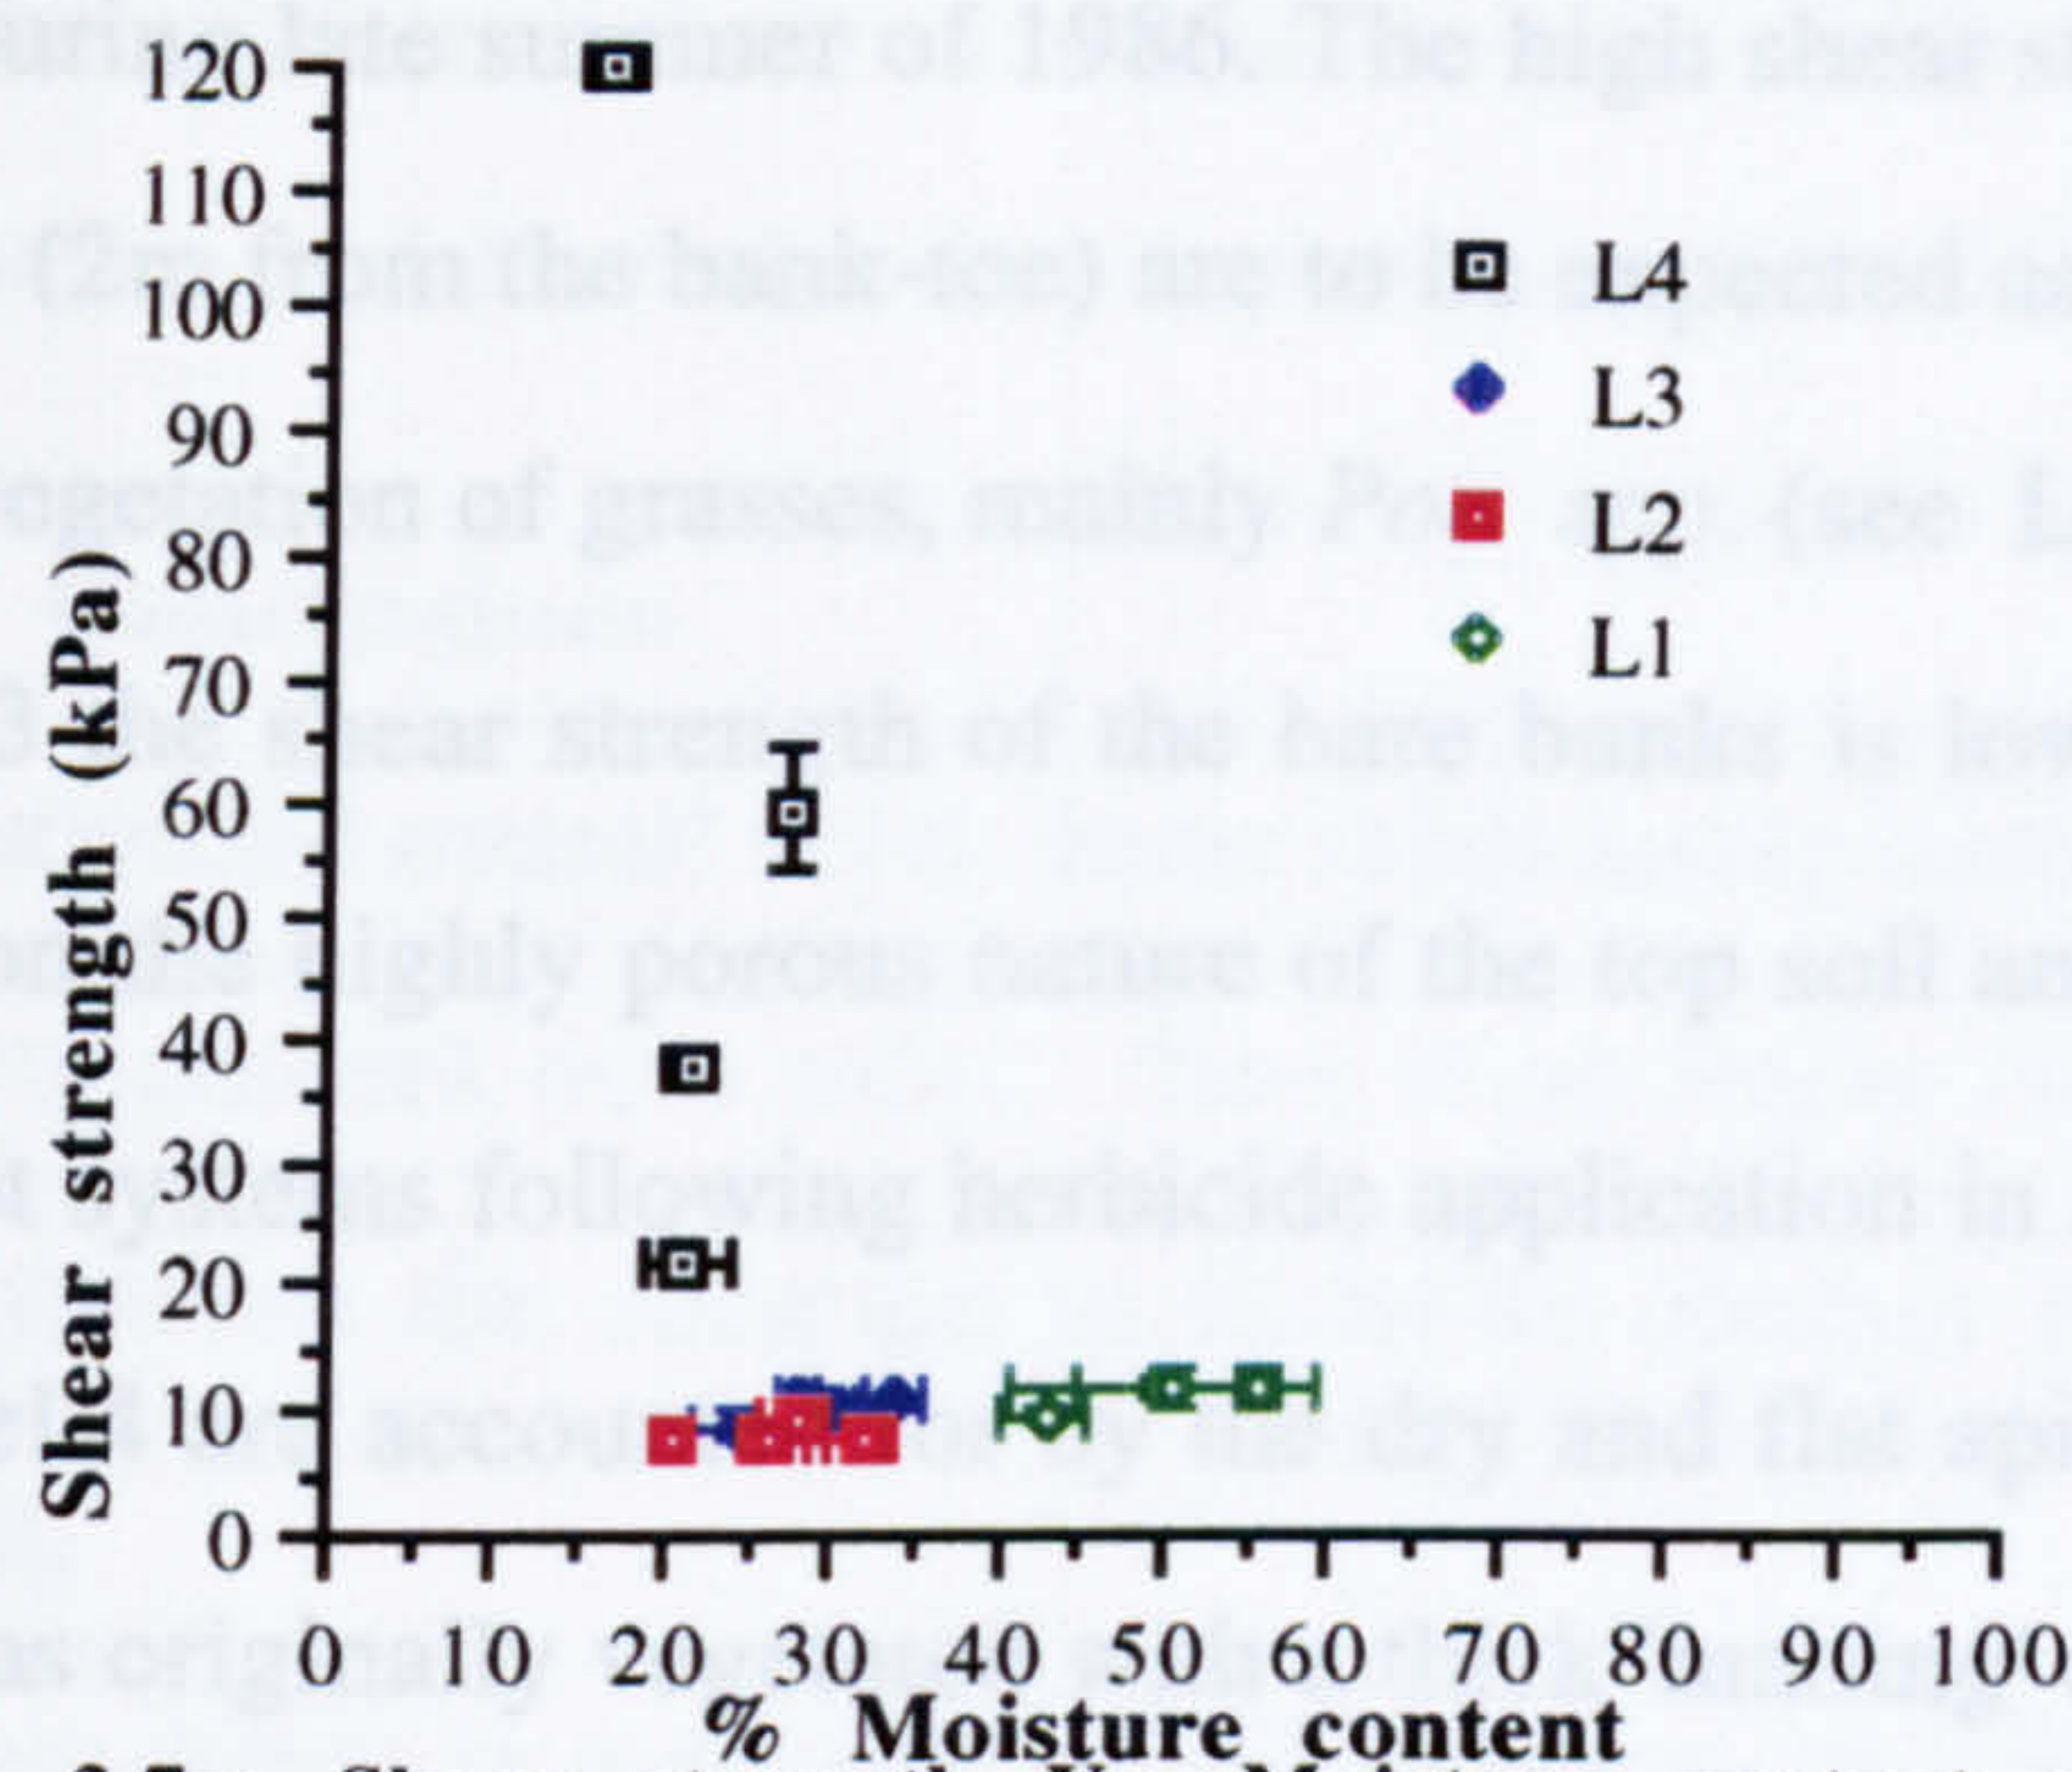
Fig. 3.7a: Shear strength Vs. Moisture content variations (August 1986) on Bare banks

- iv) Bare banks show similar curvilinear relationships of shear strength and moisture content to naturally vegetated banks. While the author expected a clearer positive relationship in terms of increase in shear strengths related to natural vegetation, there is no marked evidence from this experiment.

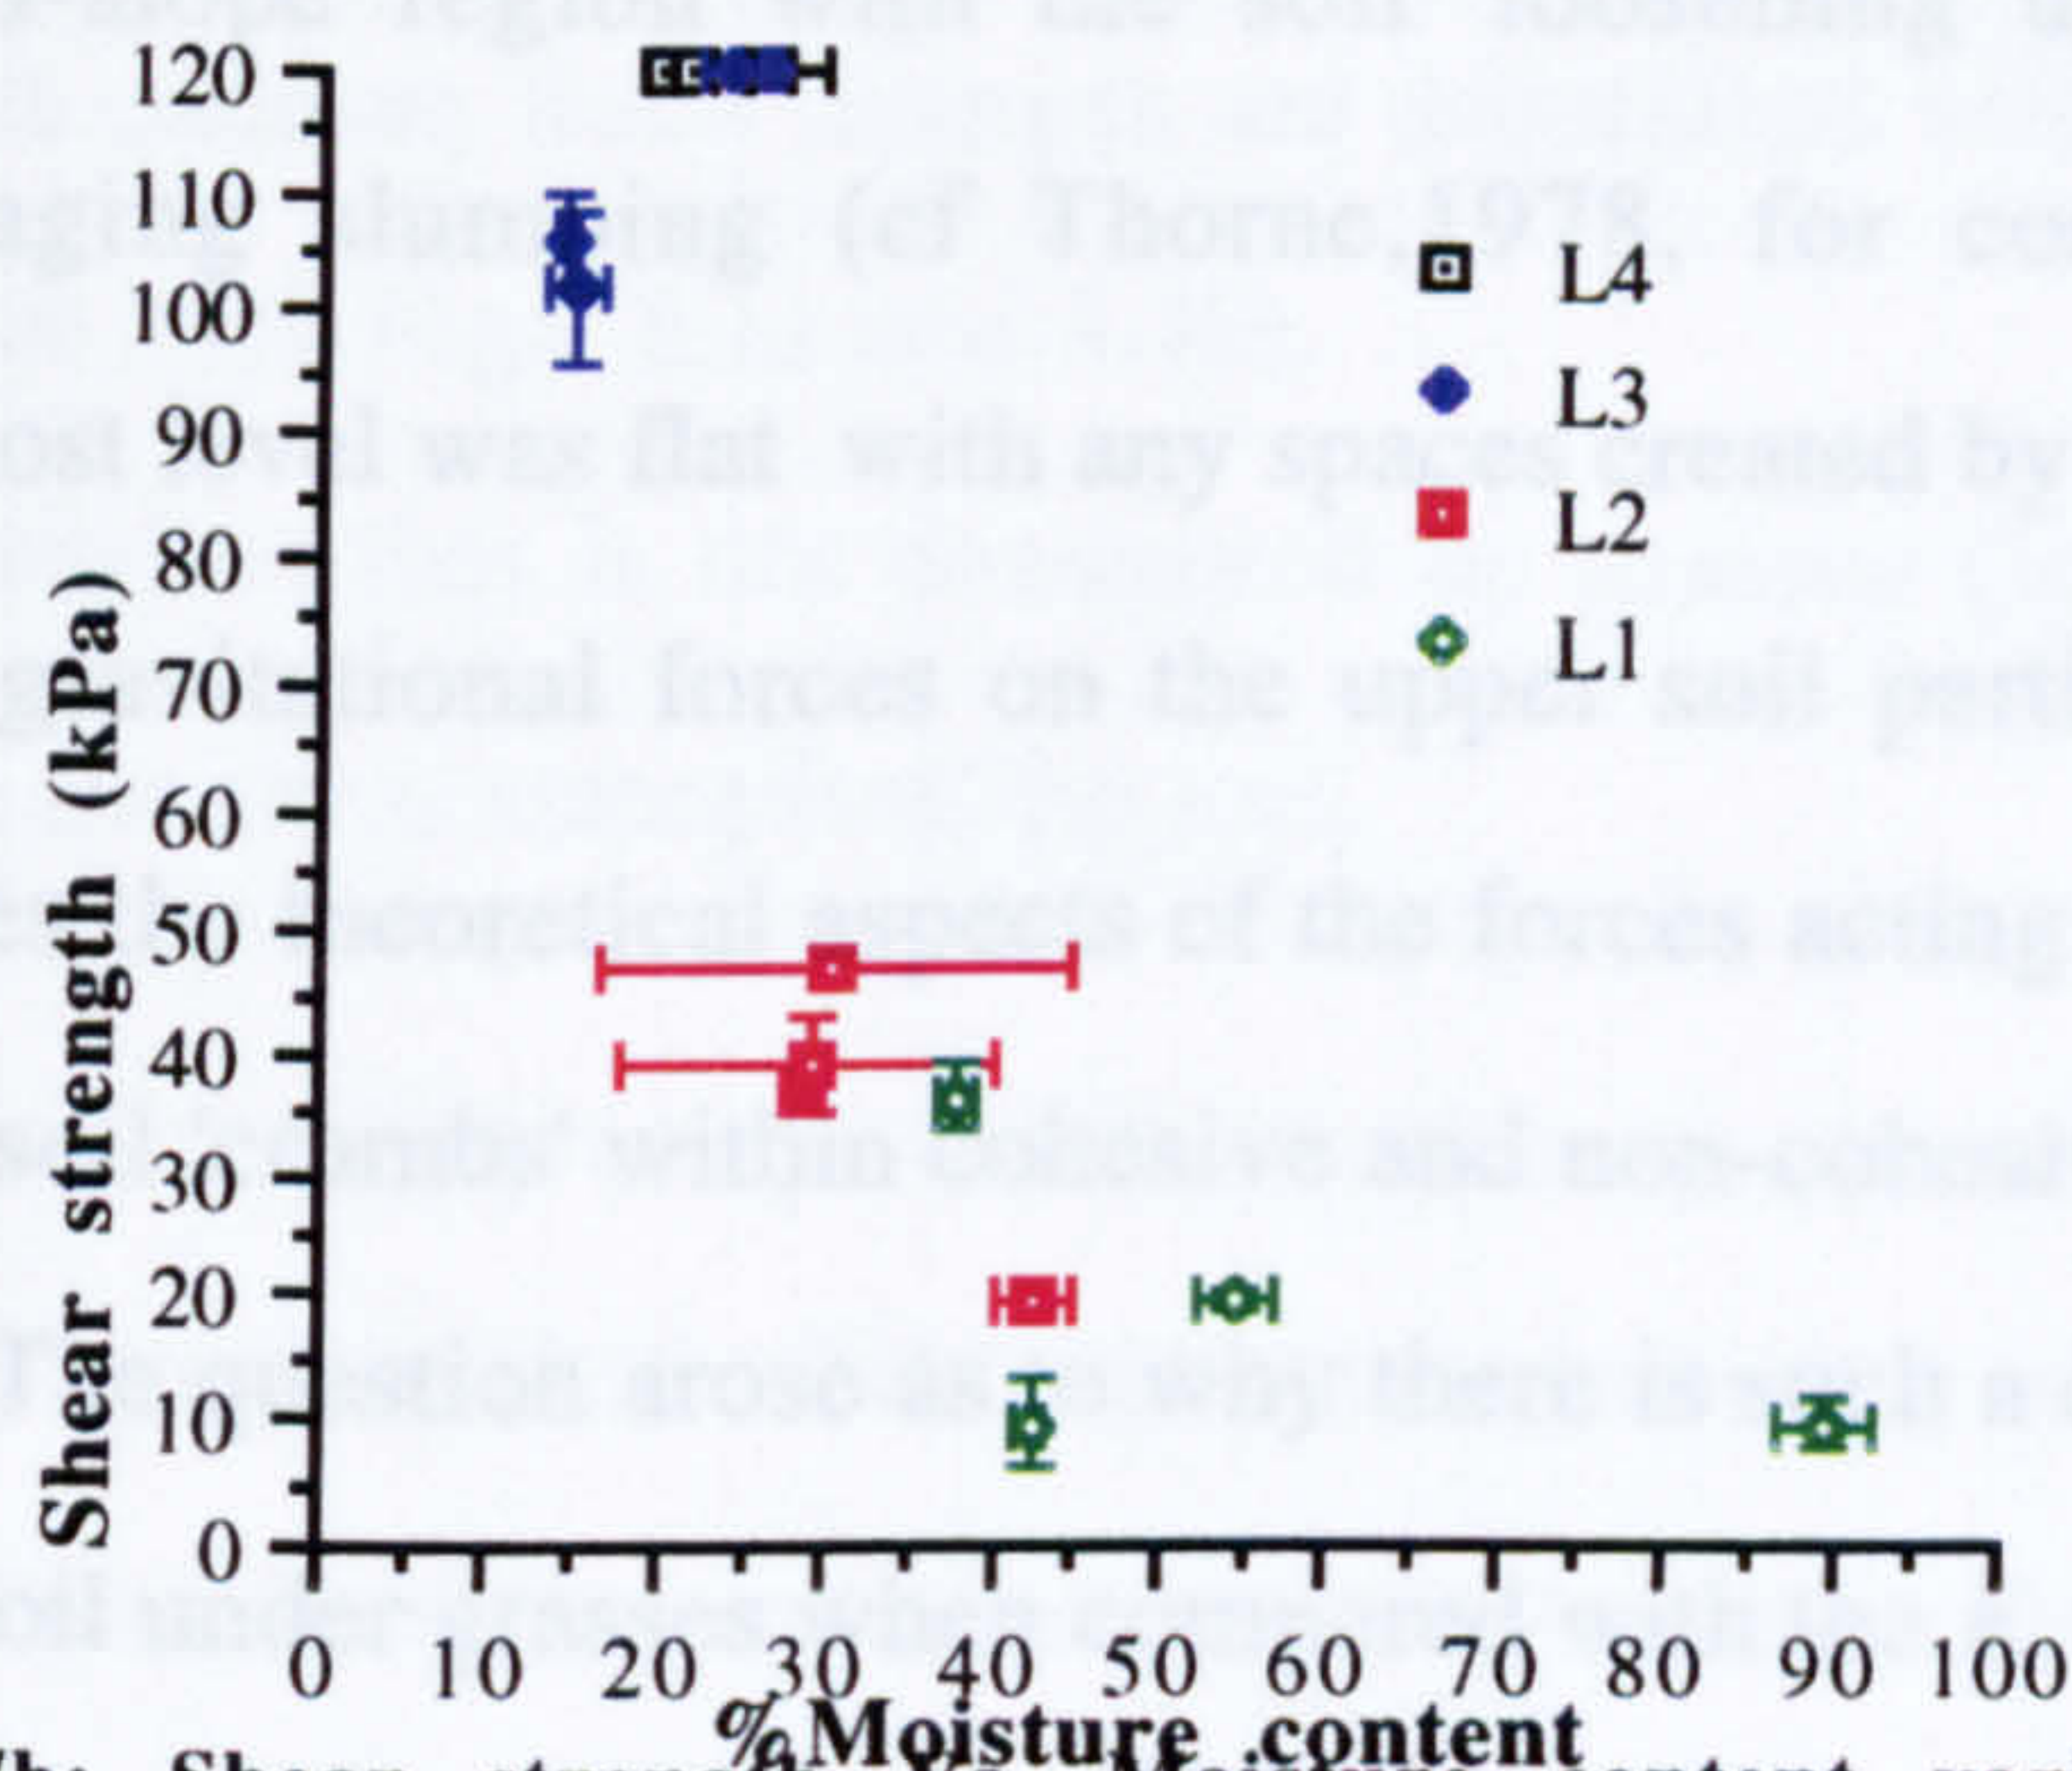
Fig. 3.7b: Shear strength Vs. Moisture content variations (August 1986) on Naturally vegetated banks dominated by *E. hirsutum* at levels 3 & 4

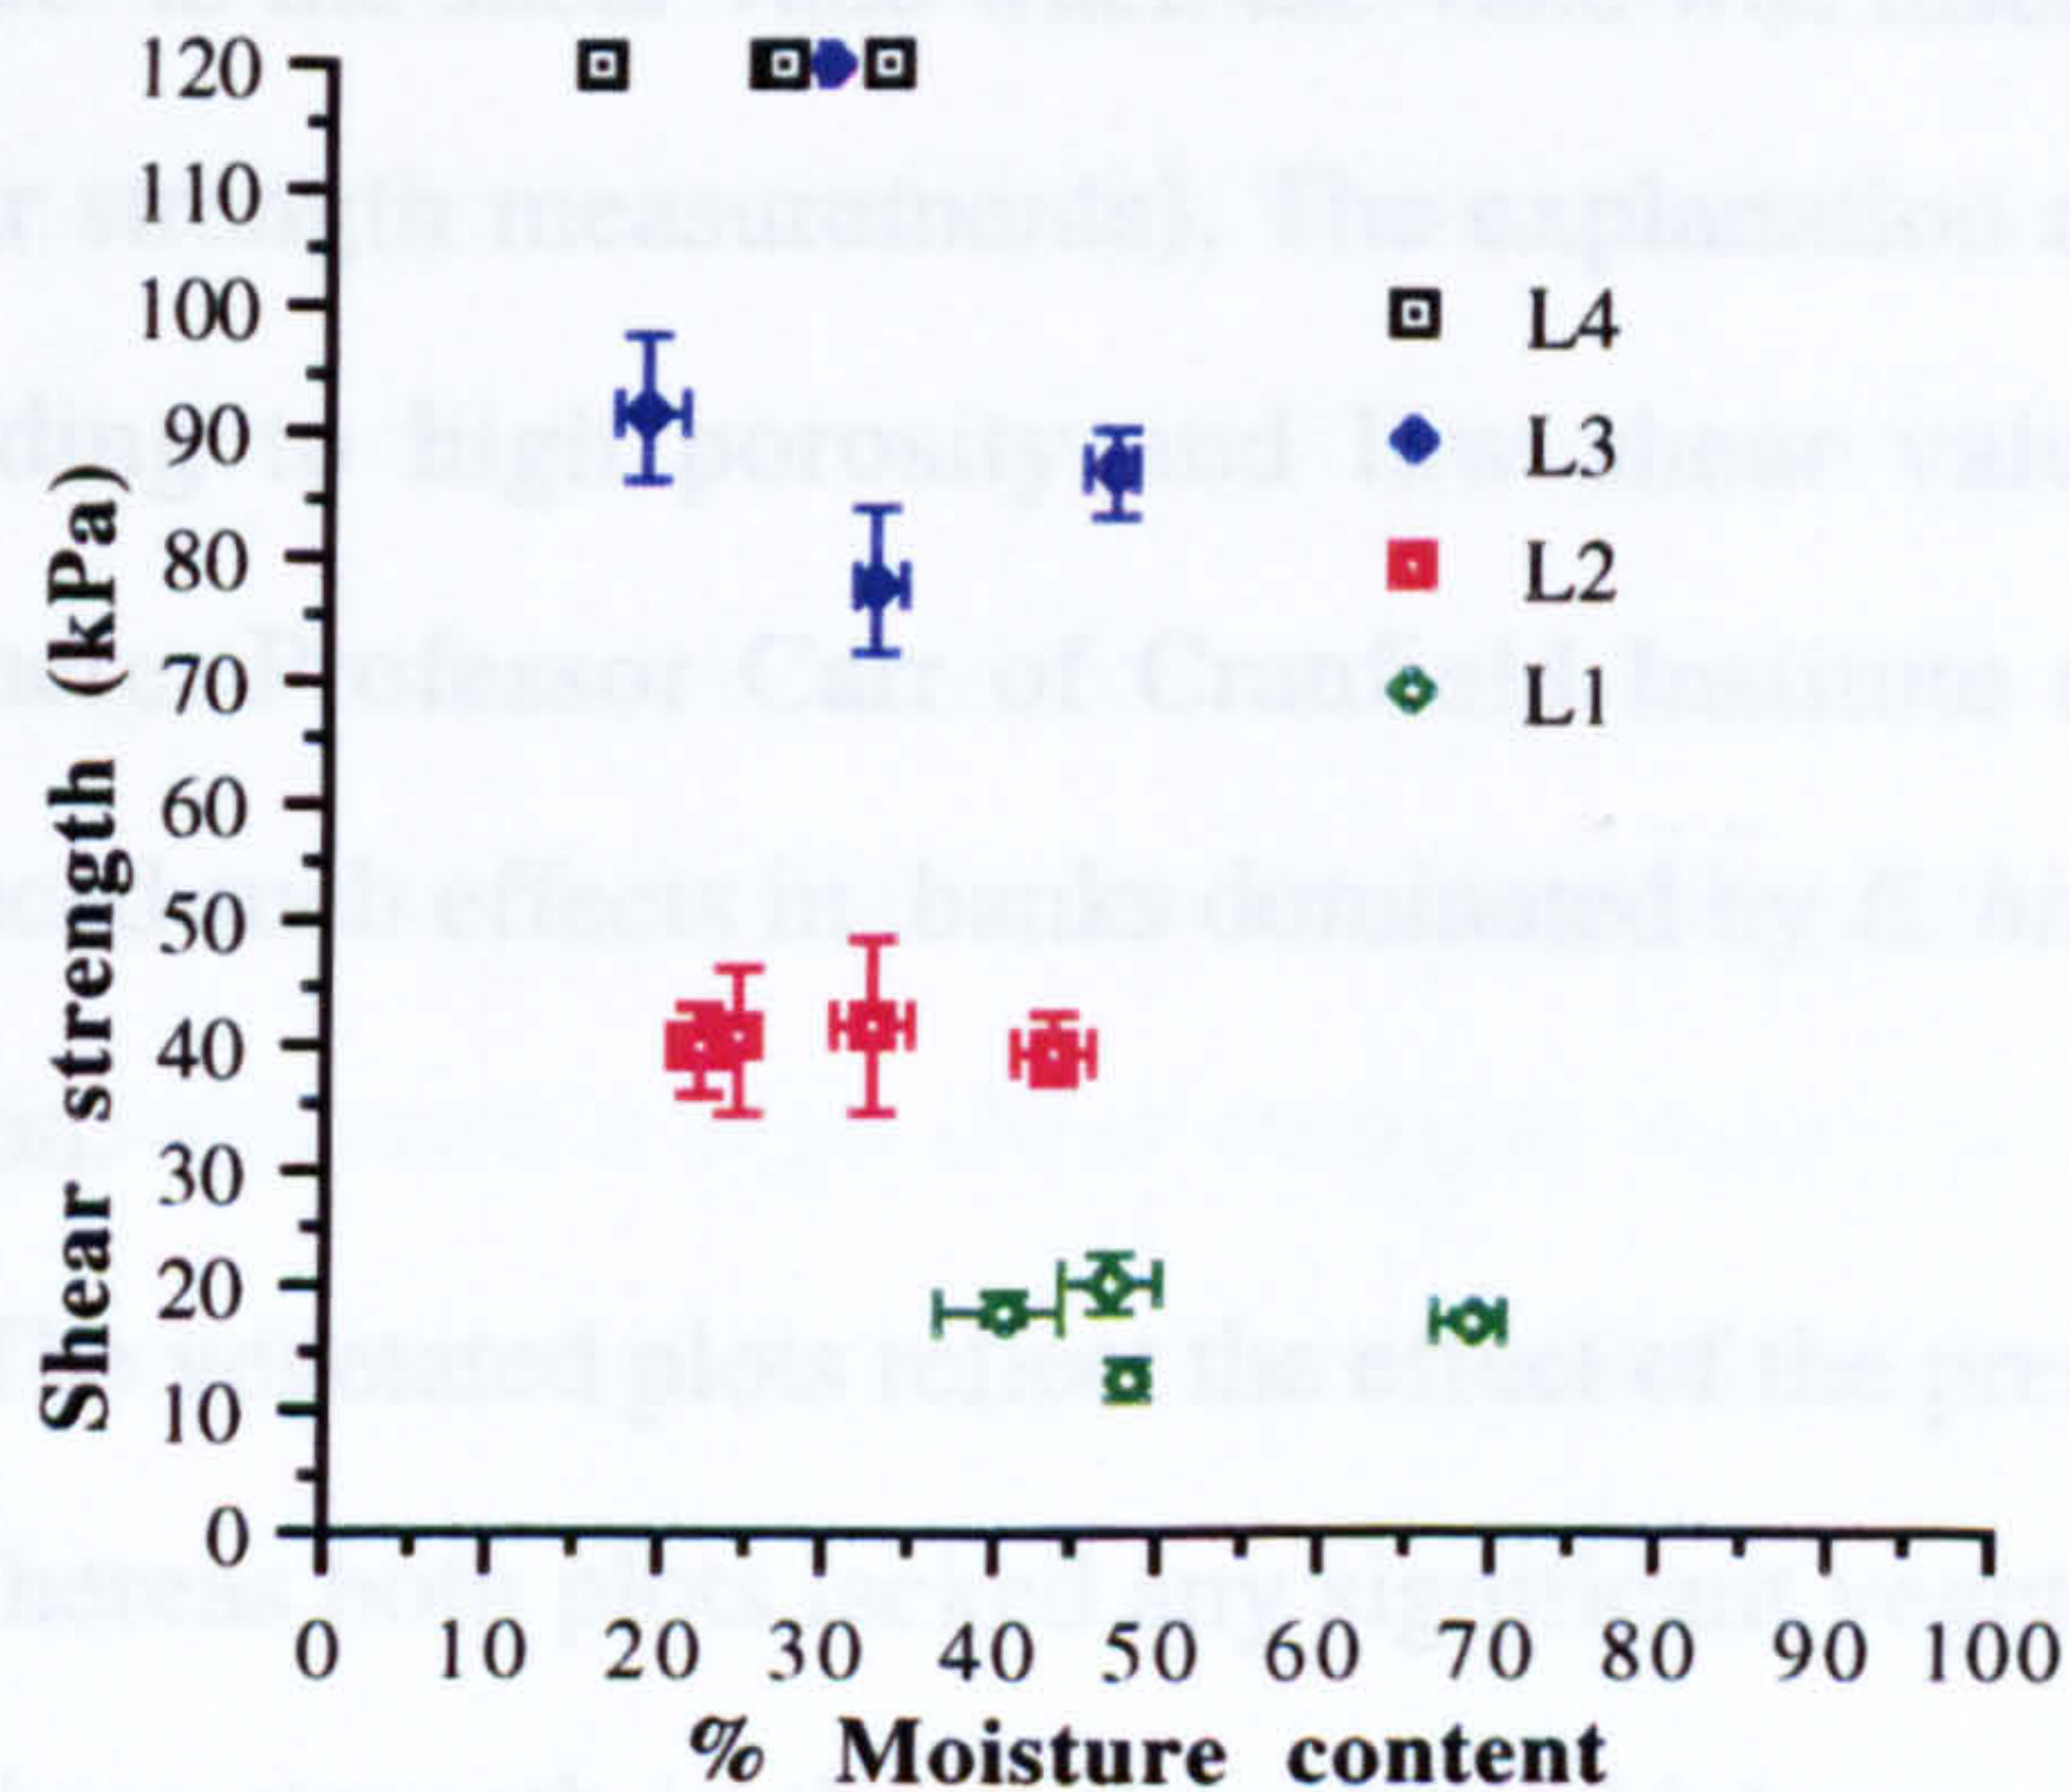
Fig. 3.7c: Shear strength Vs. Moisture content variations (August 1986) on Naturally vegetated banks dominated by *U. dioica* at levels 2 to 4

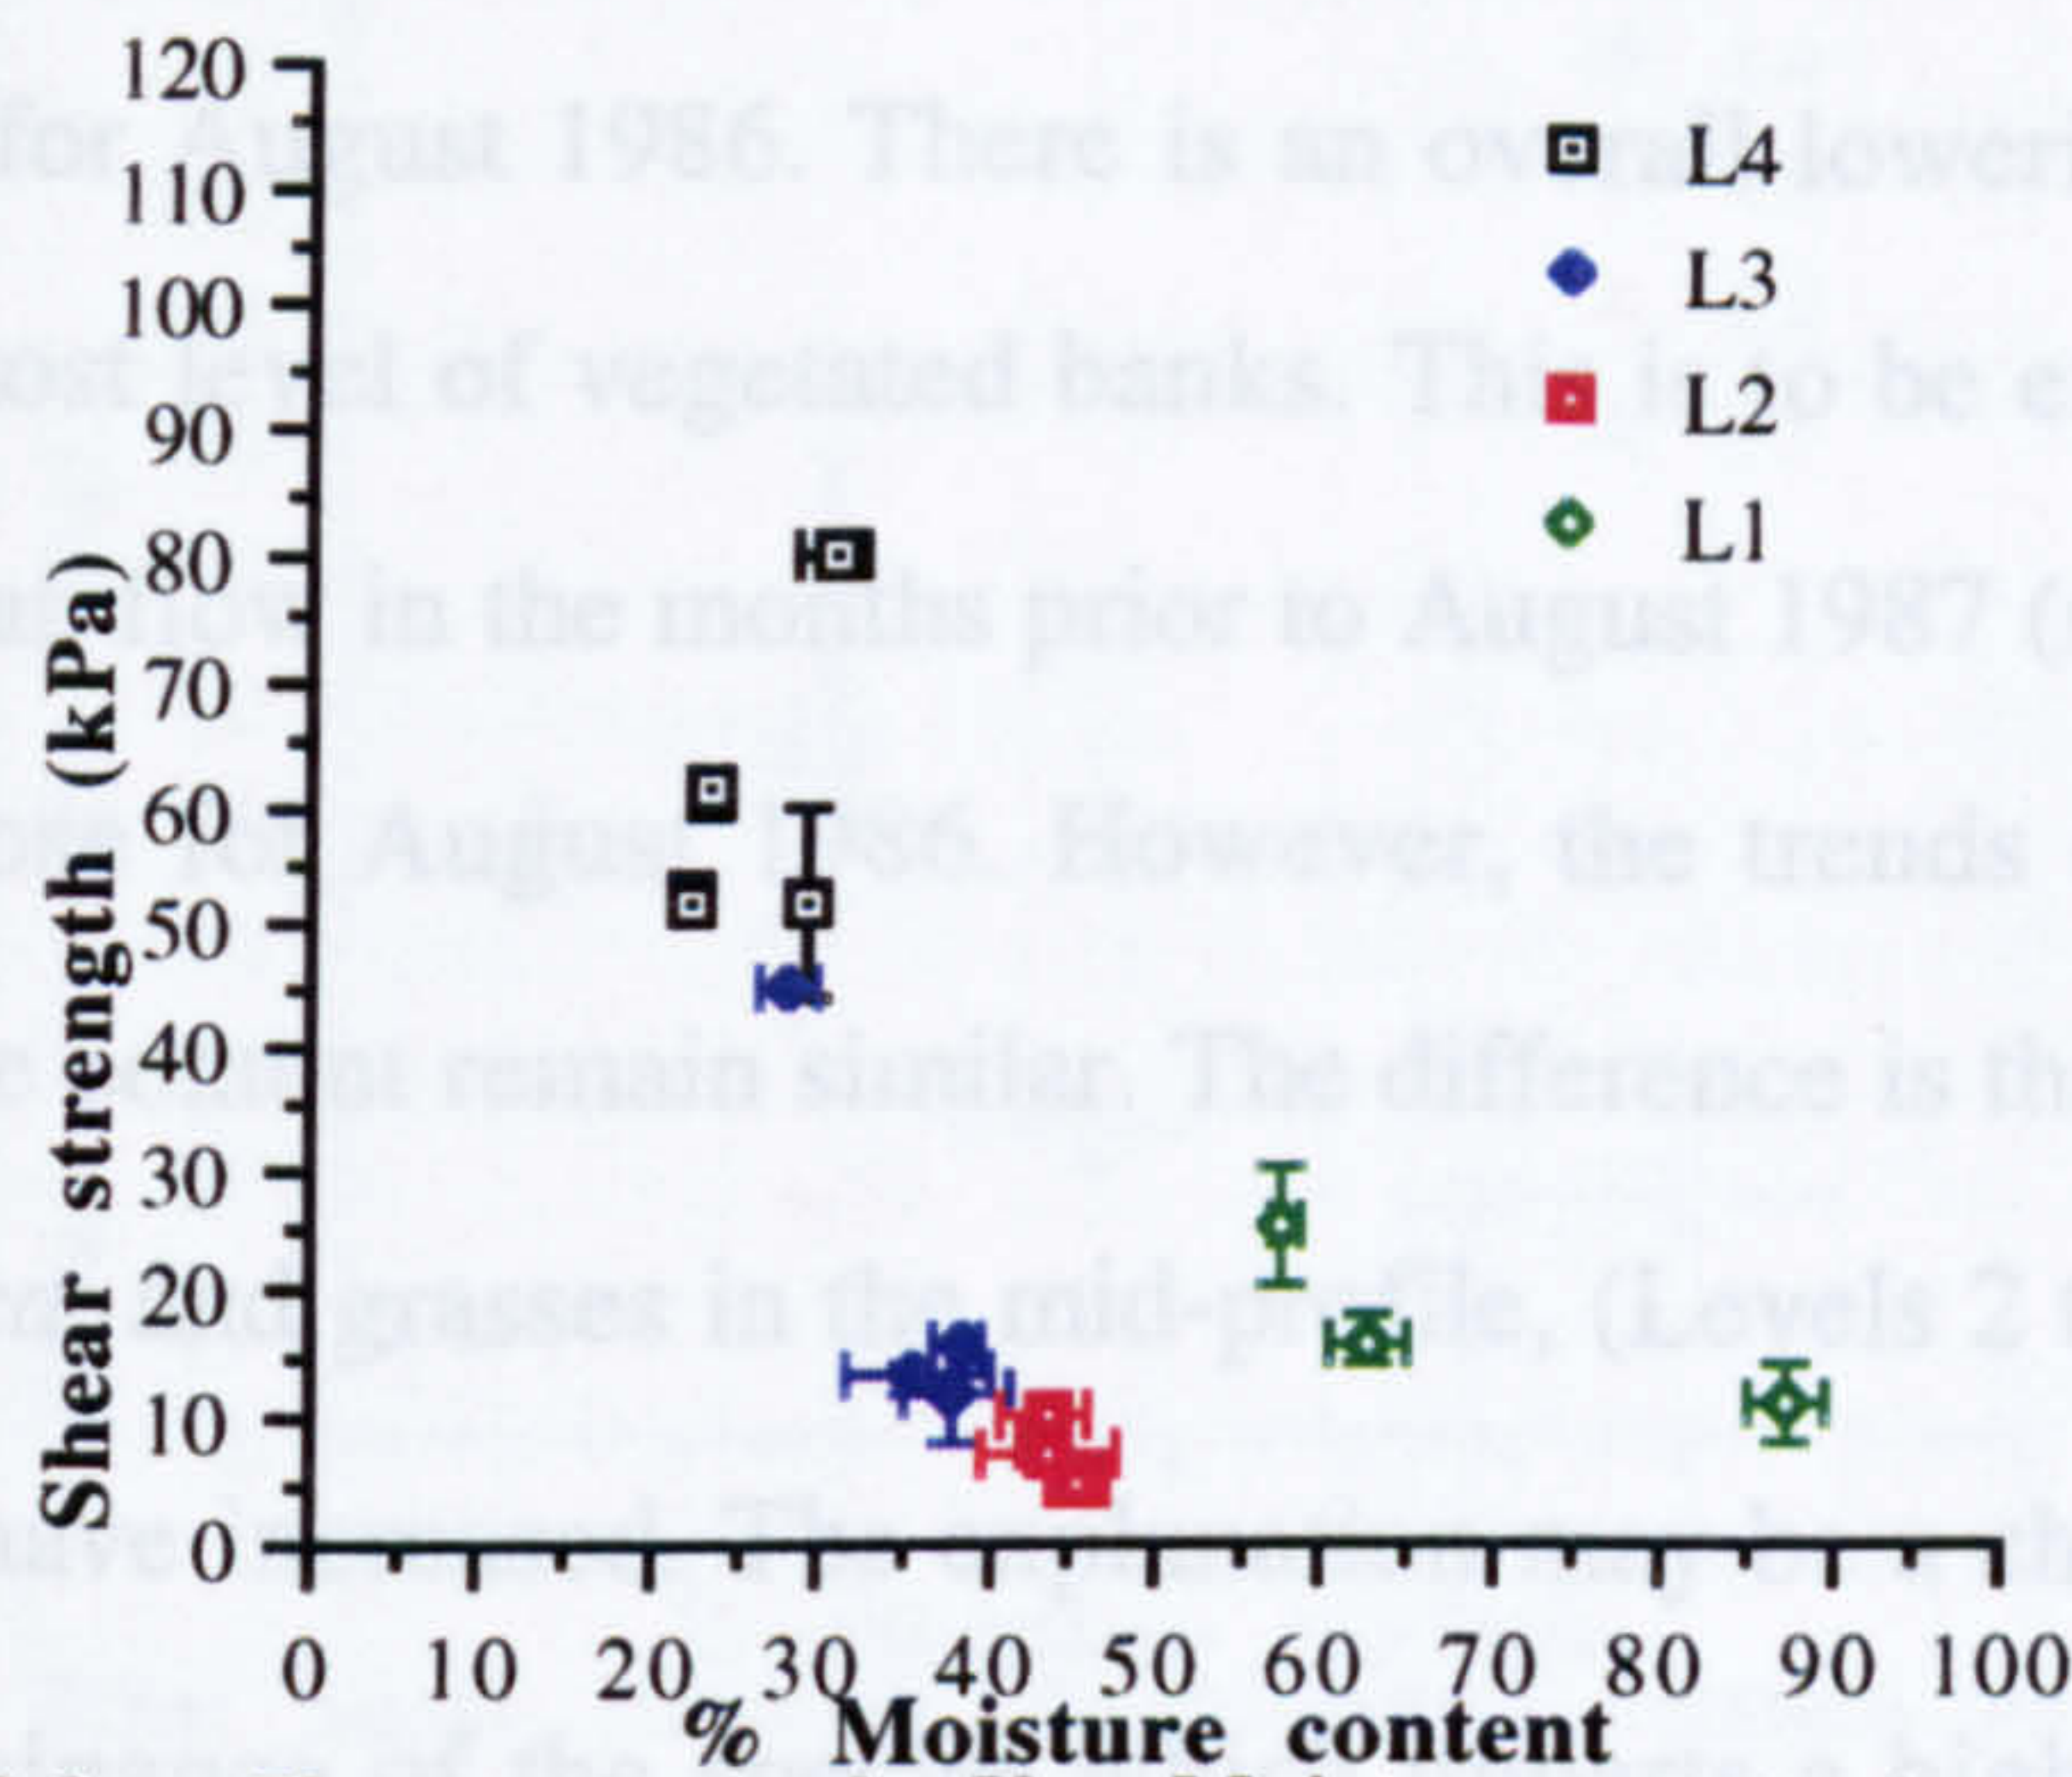
Fig. 3.8a: Shear strength Vs. Moisture content variations (February 1987)
on Bare banks

- i) it is still not clear whether there is a relationship in the variations of shear strength and moisture contents explainable as a direct effect of vegetation on the banks;
- ii) the above conclusion has to be qualified further in terms of which component/s of the bank vegetation (phyllospheric or rhizospheric effects) are important in prevention of bank erosion; If the roots do not increase the shear strength of the soil but the presence of vegetation negates erosion quite significantly, then one has to discount the first hypothesis (i.e. roots of bank vegetation increase the shear strength of the soil beyond its

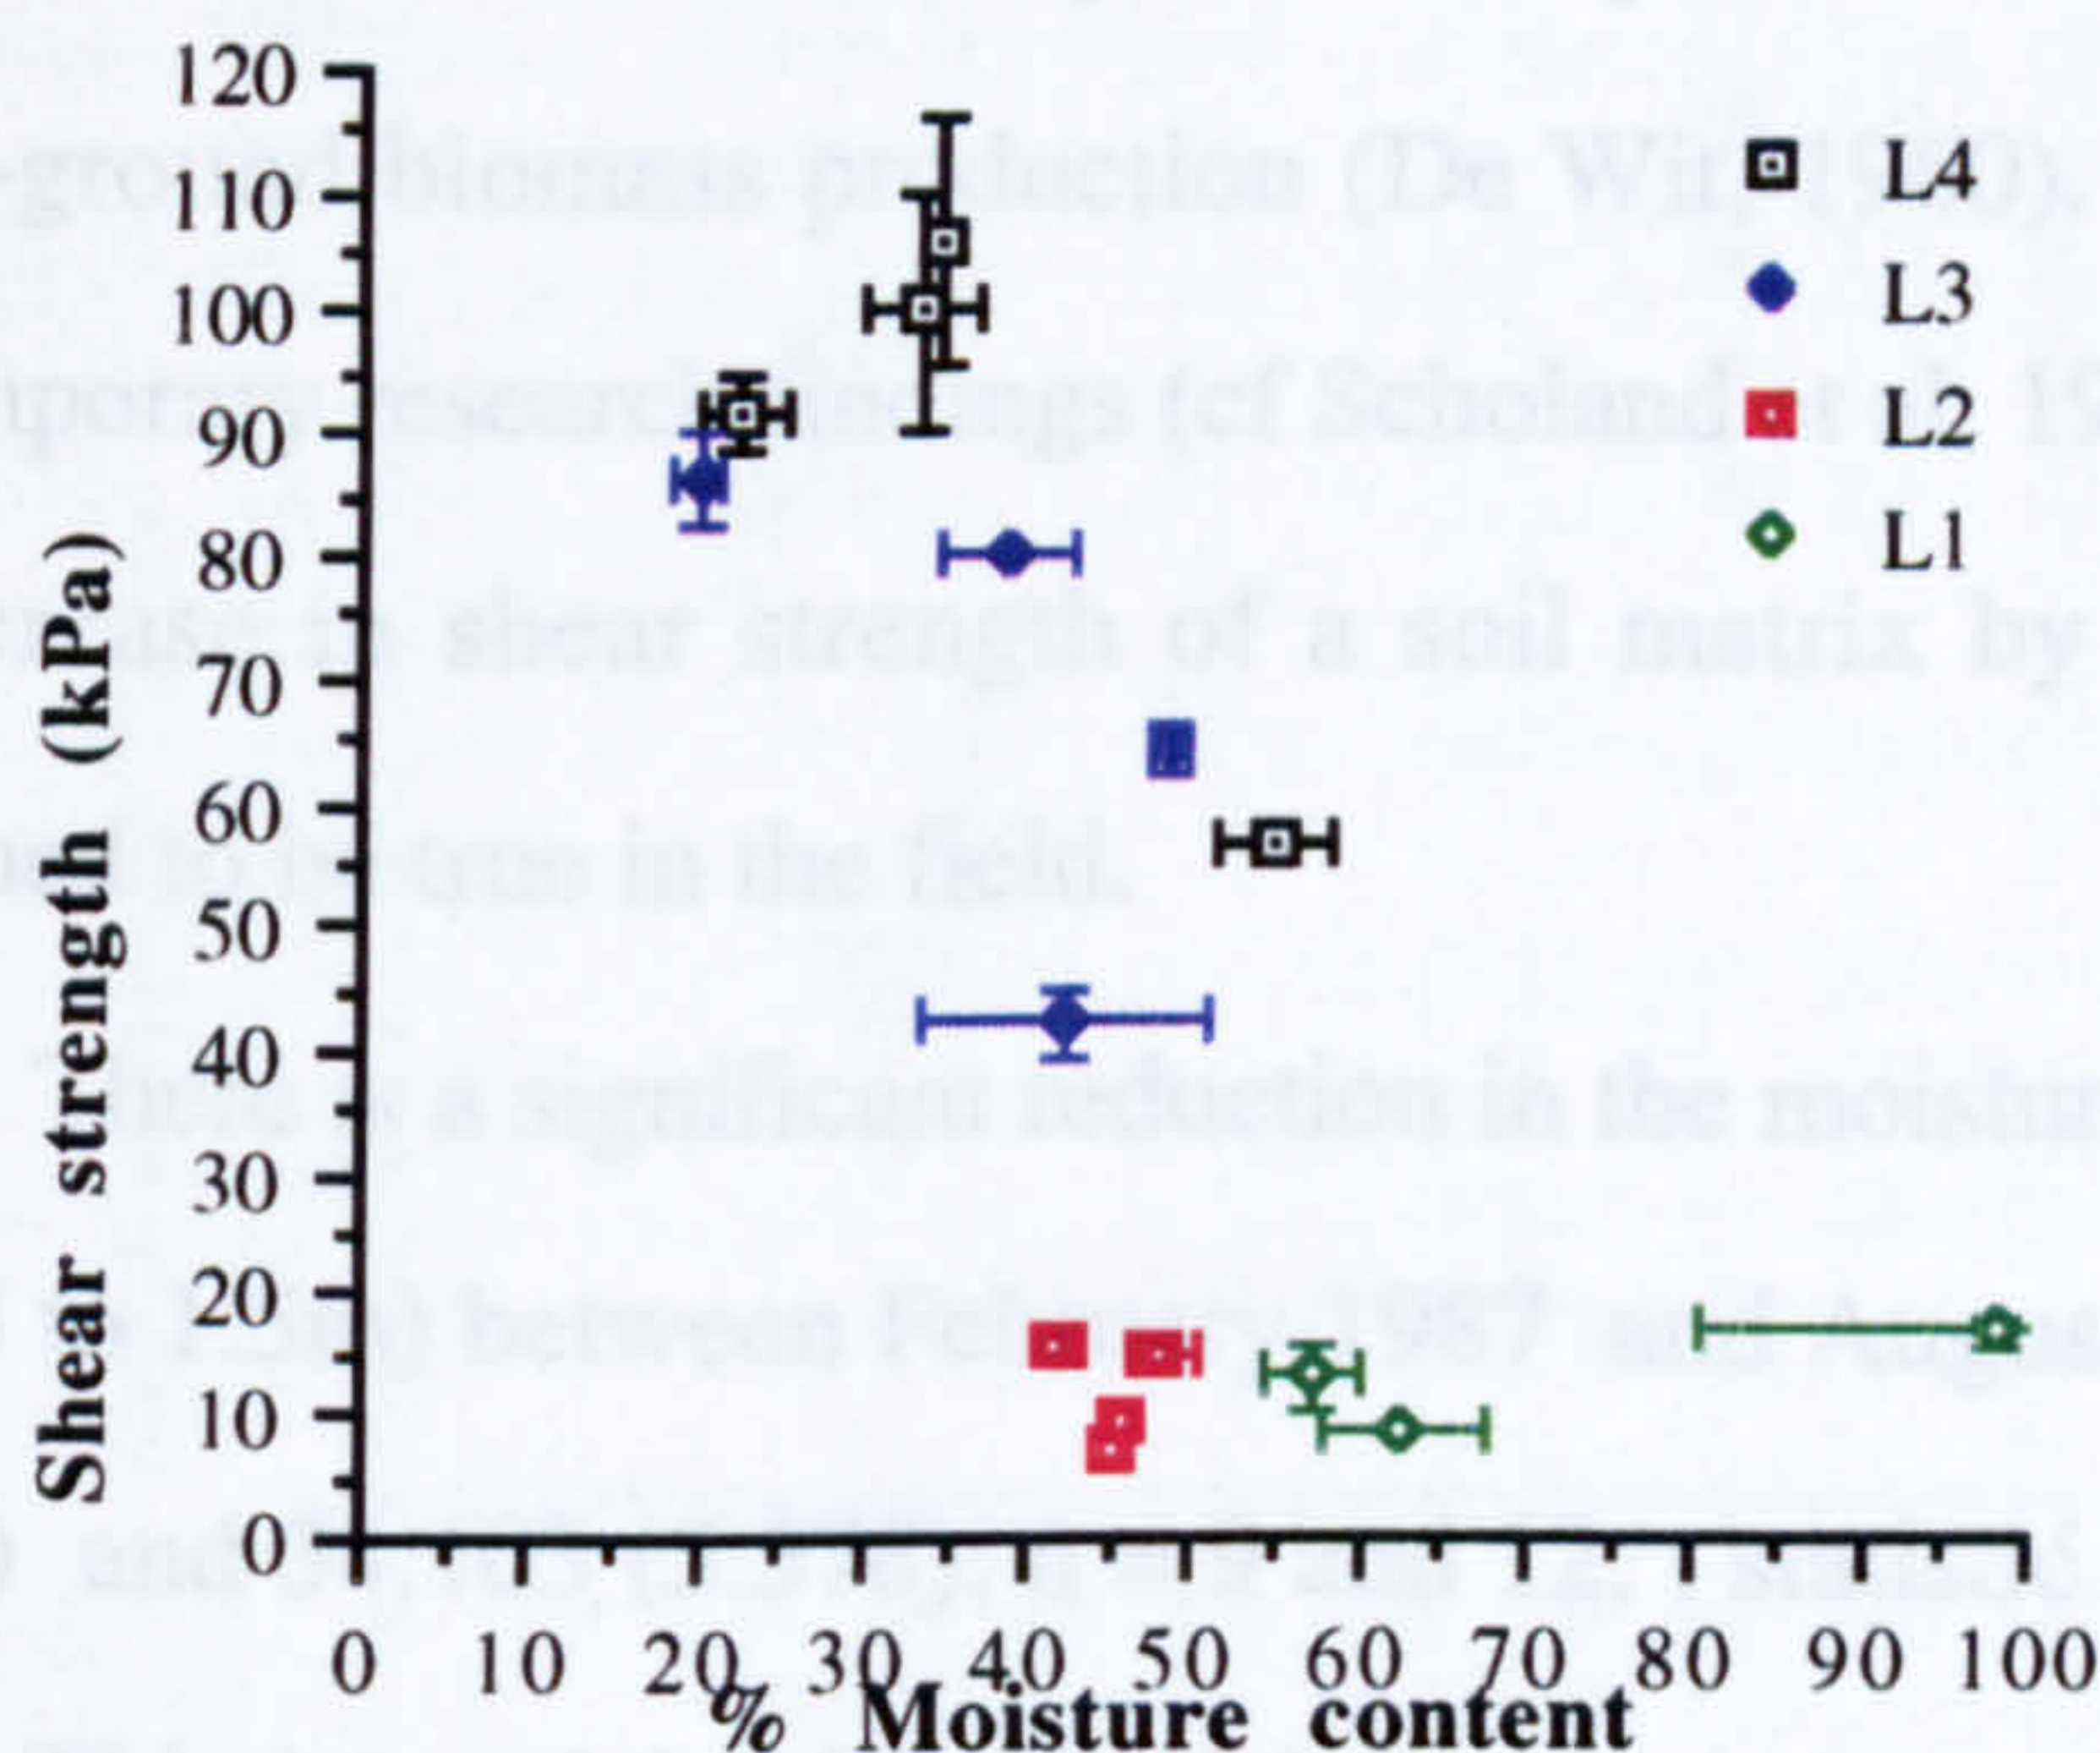
Fig. 3.8b: Shear strength Vs. Moisture content variations (February 1987)
Naturally vegetated banks dominated by *E. hirsutum* at levels 2 to 4

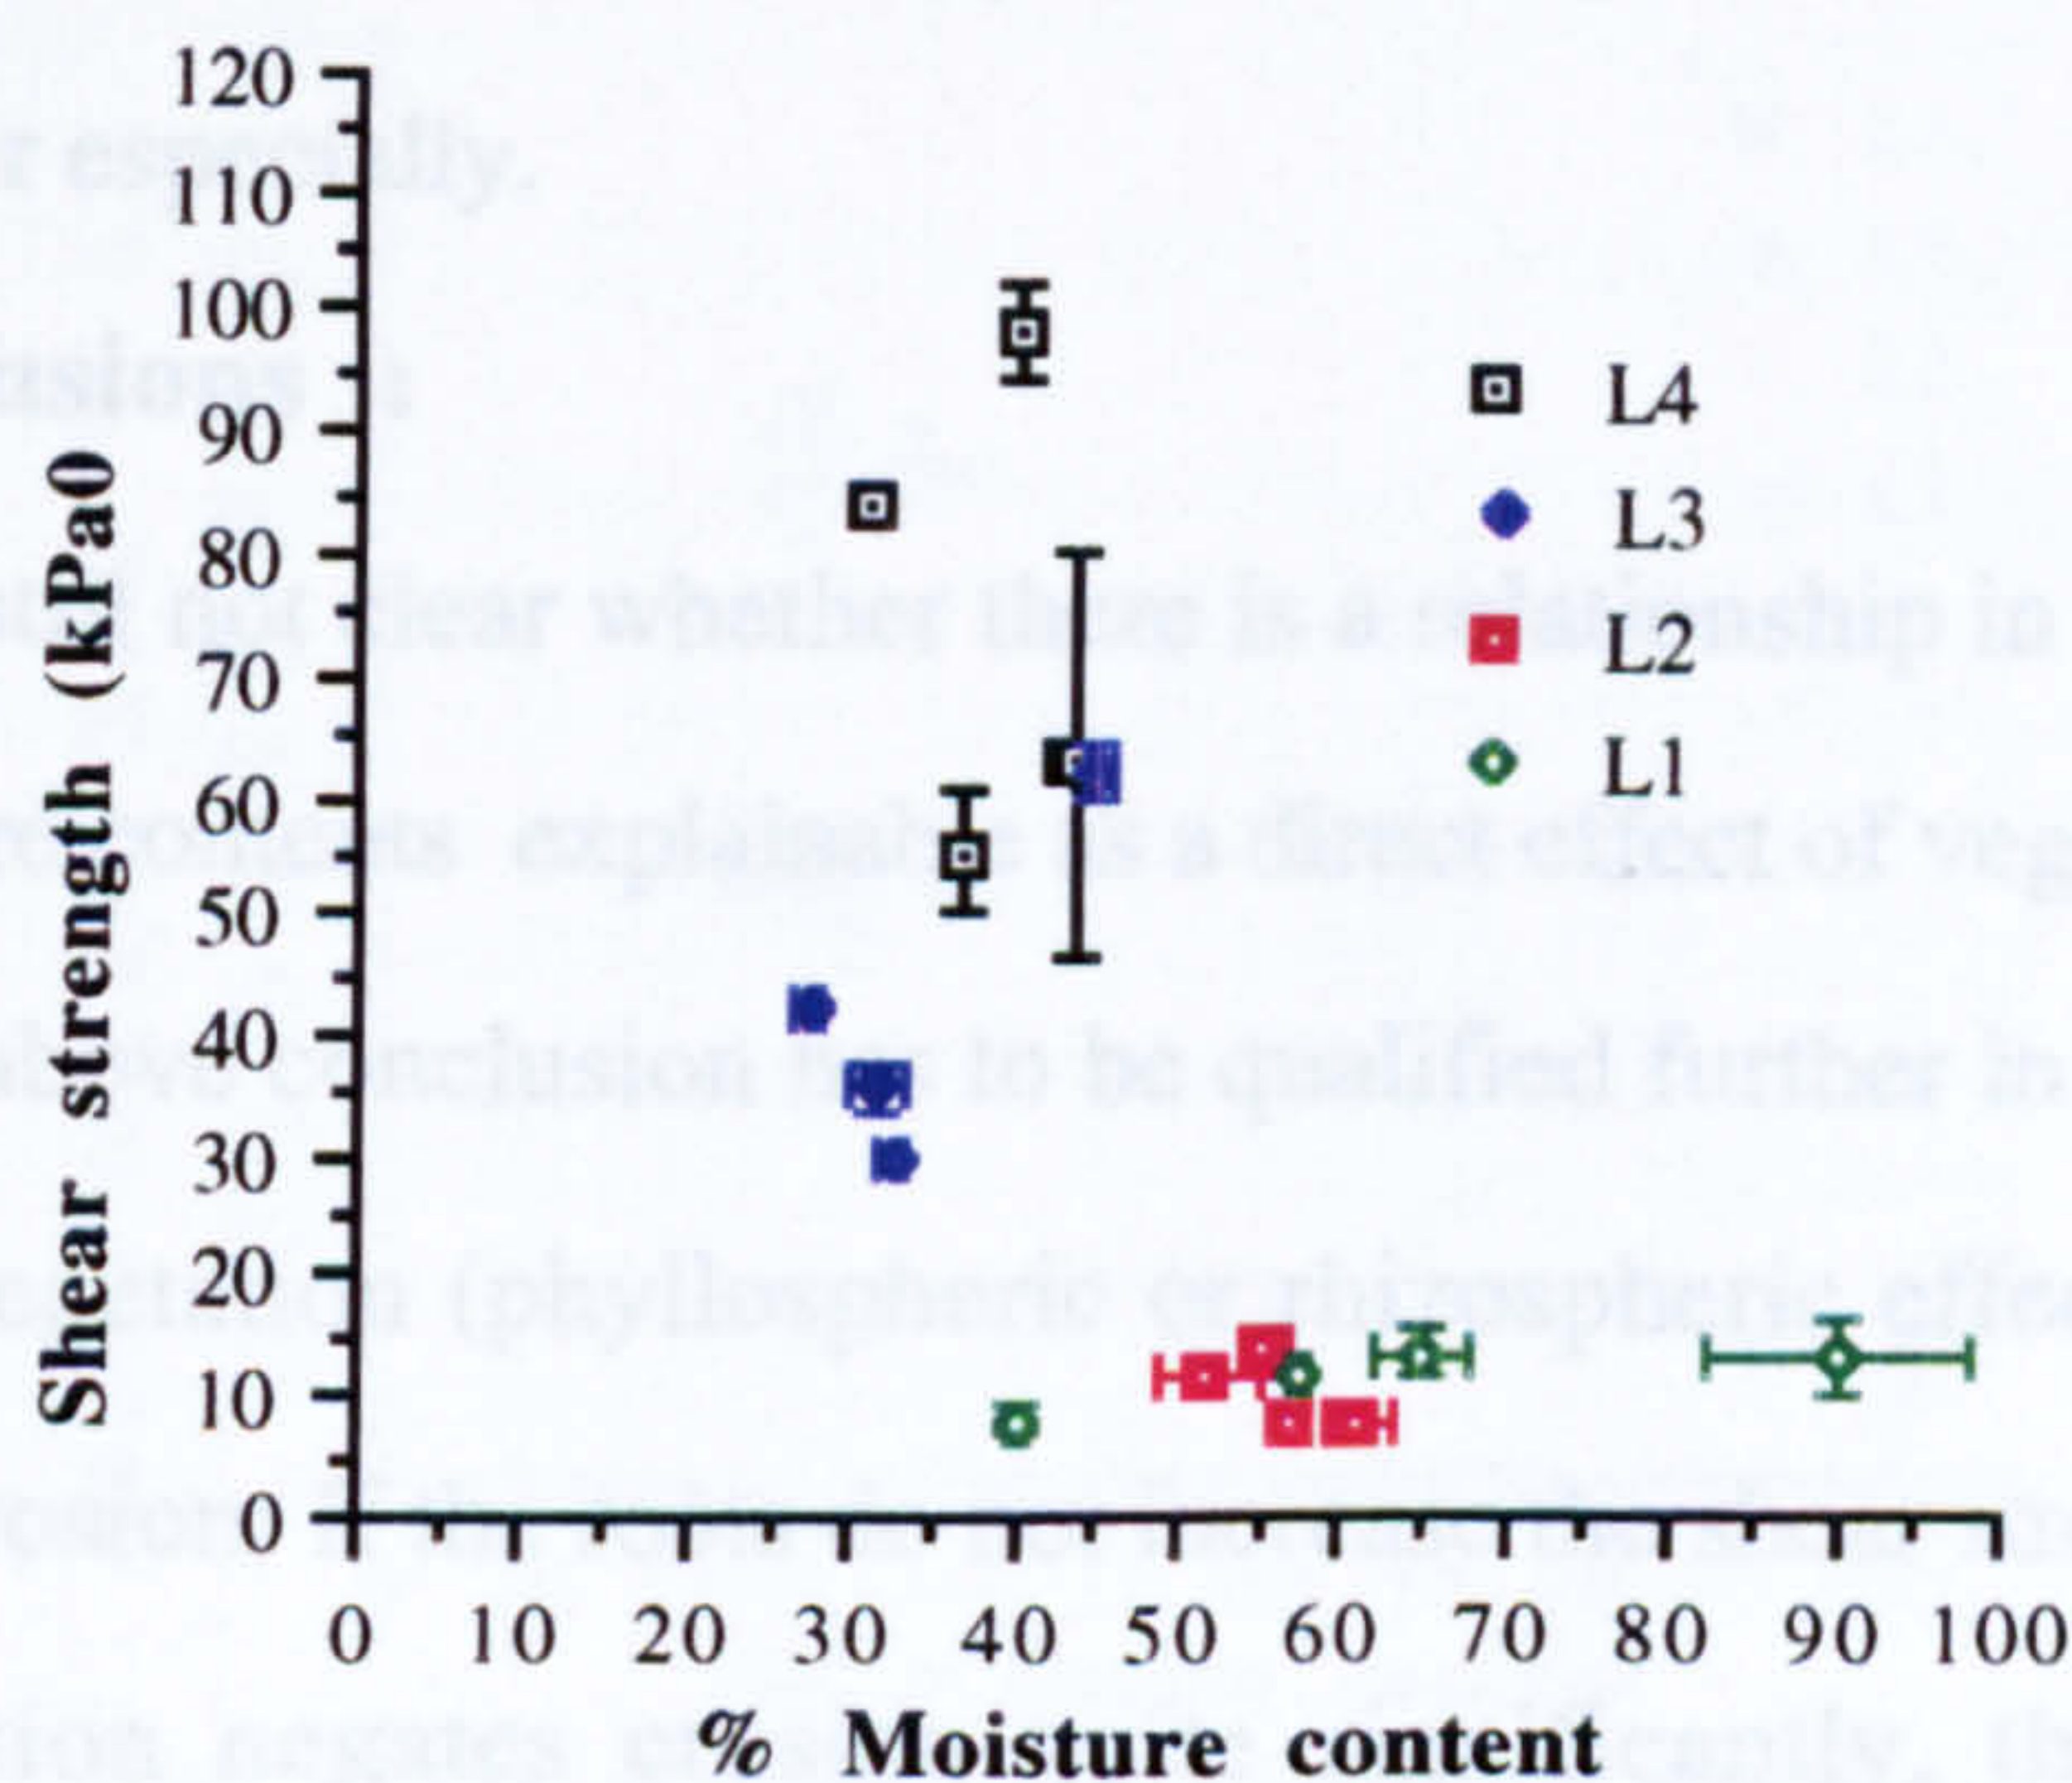
Fig. 3.8c: Shear strength Vs. Moisture content variations (February 1987)
Naturally vegetated banks dominated by *U. dioica*
